# Exhibit D

**IN THE COURT OF COMMON PLEAS OF DELAWARE COUNTY, PA**  
**CIVIL ACTION - LAW**

**C. Exterior Façade/Cladding Defects throughout the Community**

Haverford Reserve  
Moisture Probe Testing  
Appendix A

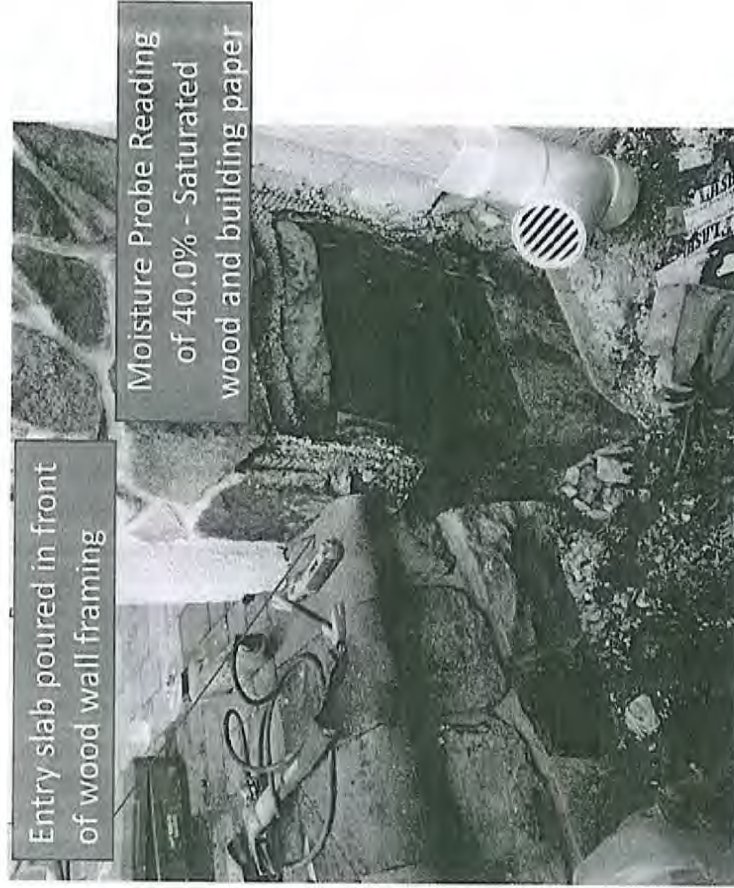
Entry slab poured in front  
of wood wall framing

Moisture Probe Reading  
of 40.0% - Saturated  
wood and building paper

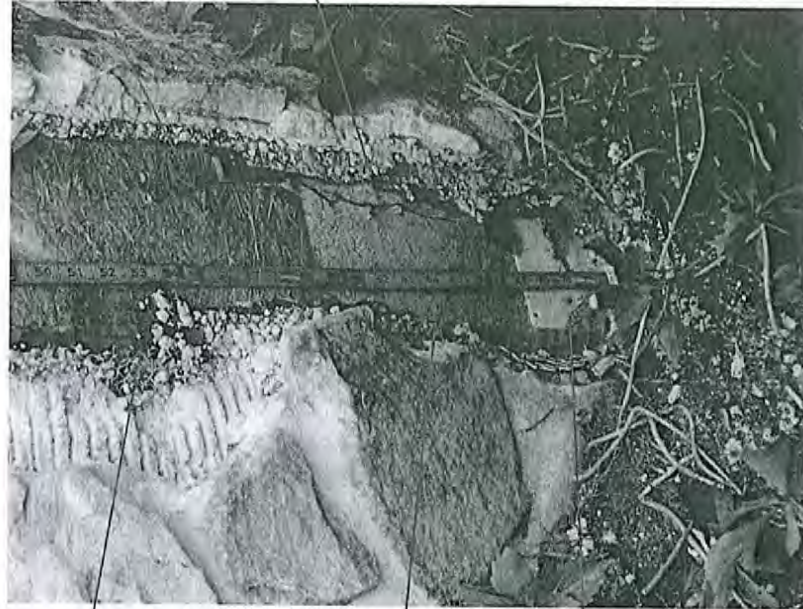
Note: 3 layers of  
building paper +  
drainage mat

Wood Moisture content  
measured at 20% (i.e.: 'wet')

Wire mesh and fasteners  
corroded

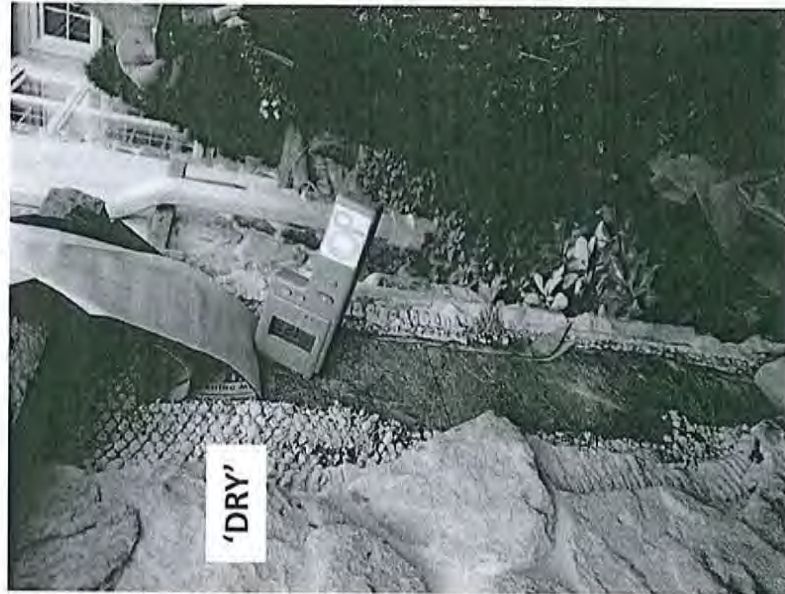
12.6% moisture approx. 32"  
above grade

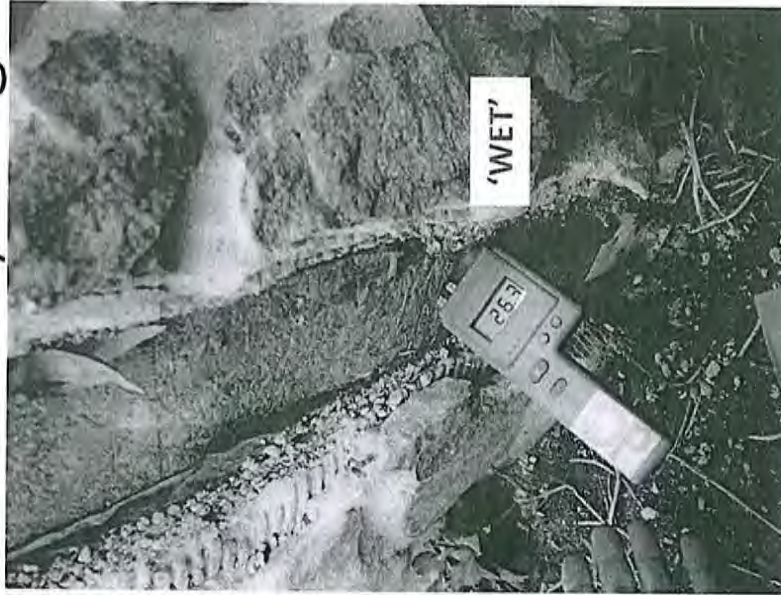
26.3% moisture at bottom of  
wood framing

Buried weep screed  
is preventing  
moisture from  
draining at the  
base of the wall

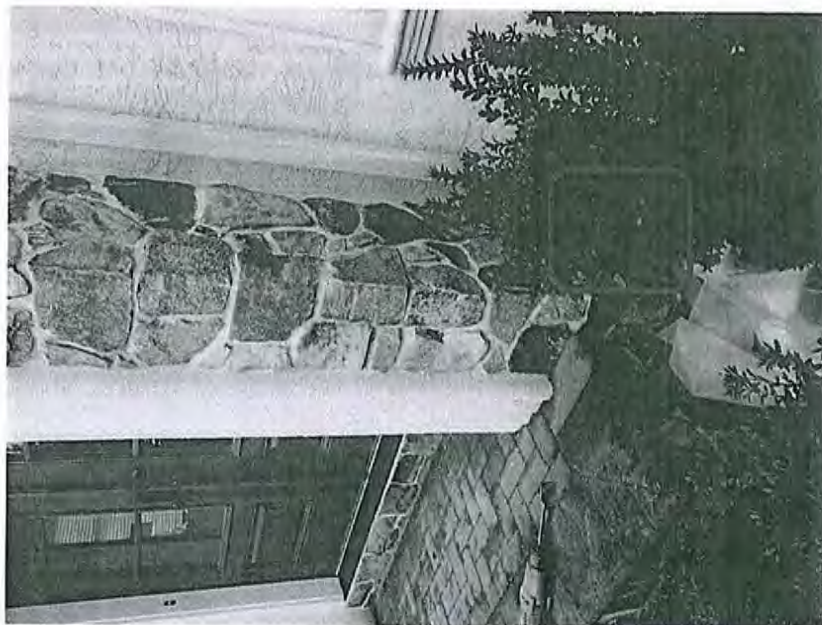
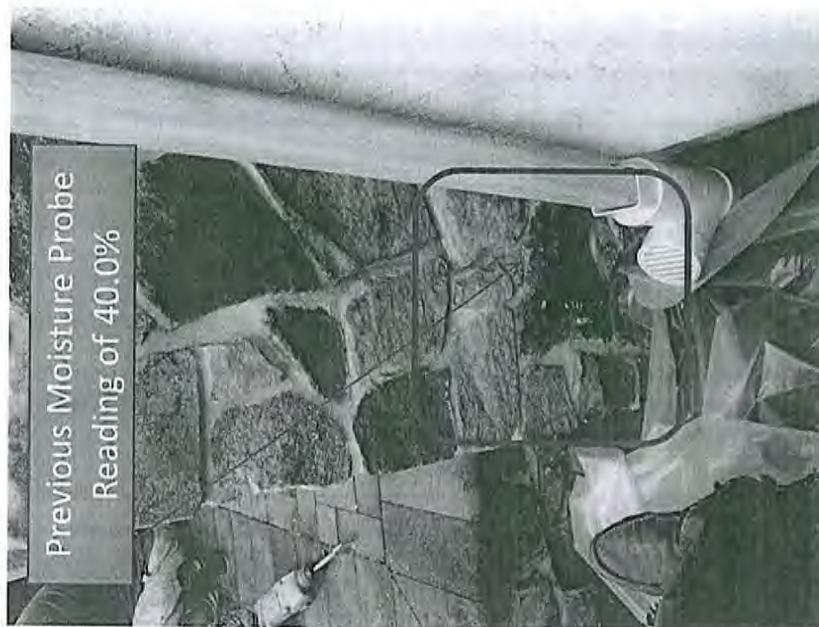
## Invasive Inspections: Location #1

HIGH MOISTURE LEVELS

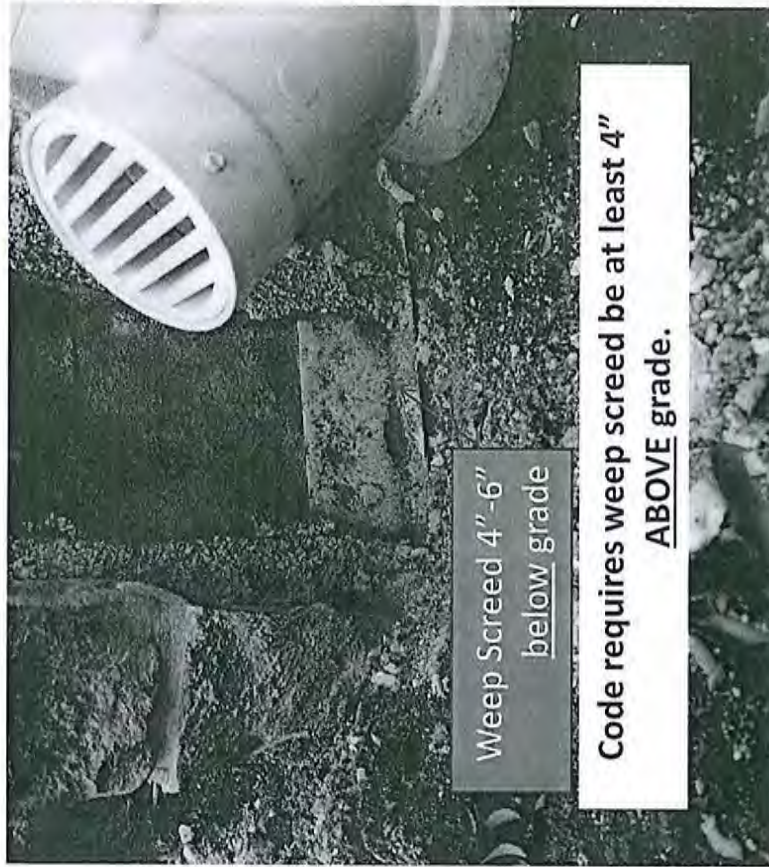
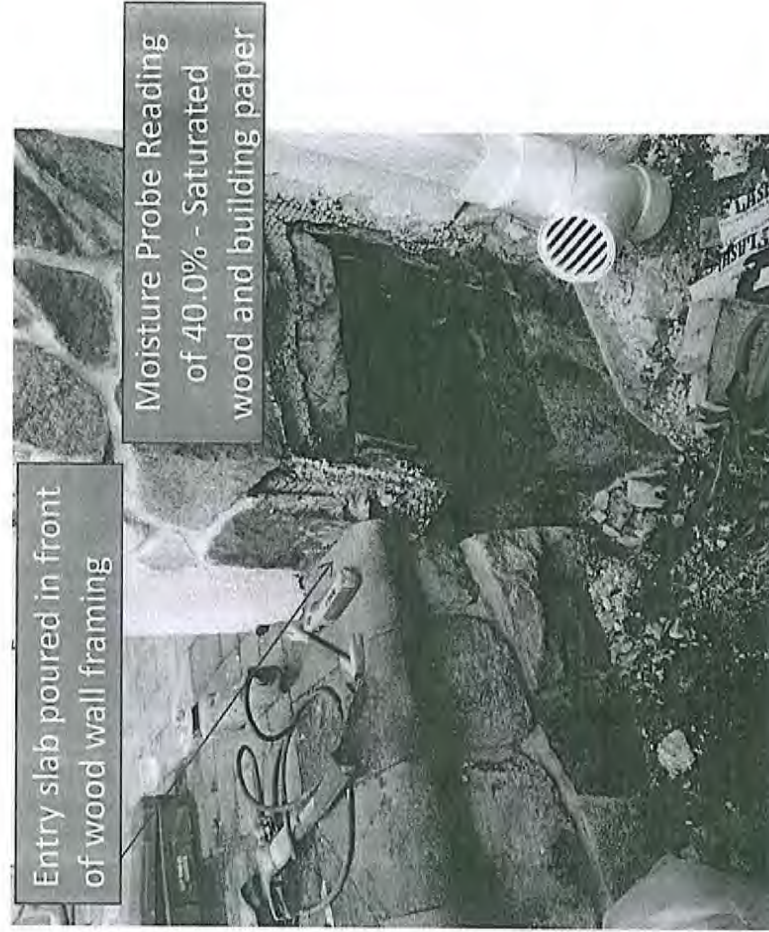
## Invasive Inspections: Location #1

**NO SYSTEM DRAINAGE**

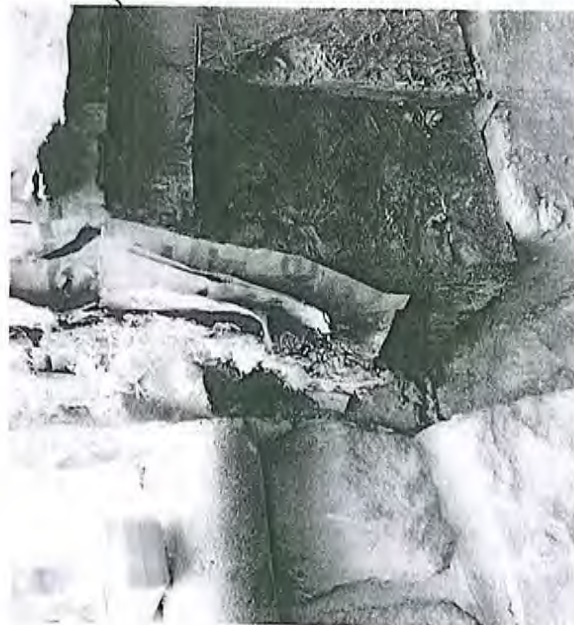
## Invasive Inspections: Location #1

Note: OSB Sheathing removed to reveal that damage extends beyond sheathing and into rim board

## STRUCTURAL WOOD DECAY

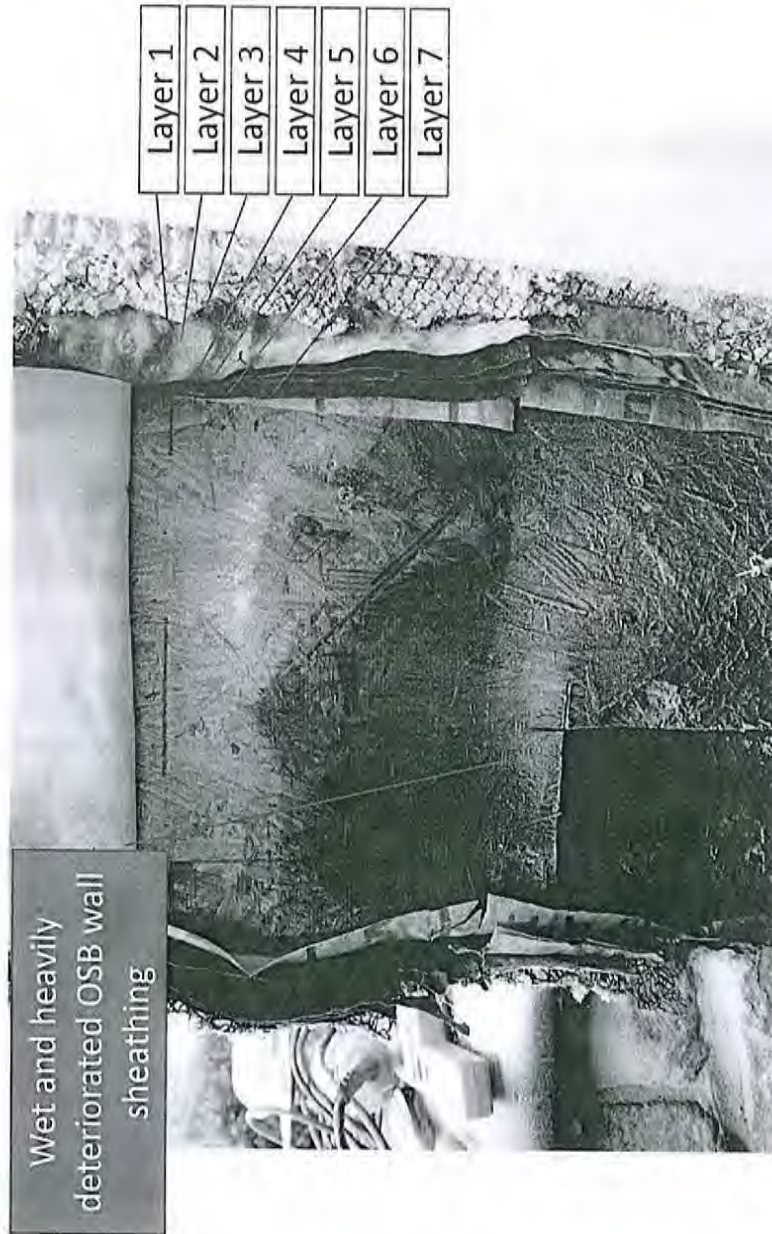
## Invasive Inspections: Location #1

7 Layers of paper at overlap areas creates breathability concerns.

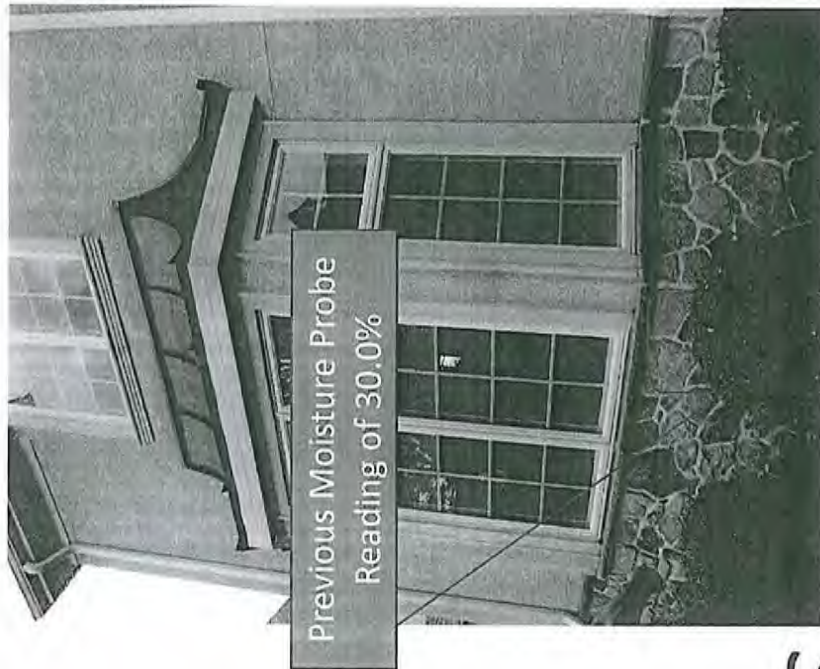
## Invasive Inspections: Location #2

# HIGH MOISTURE LEVELS

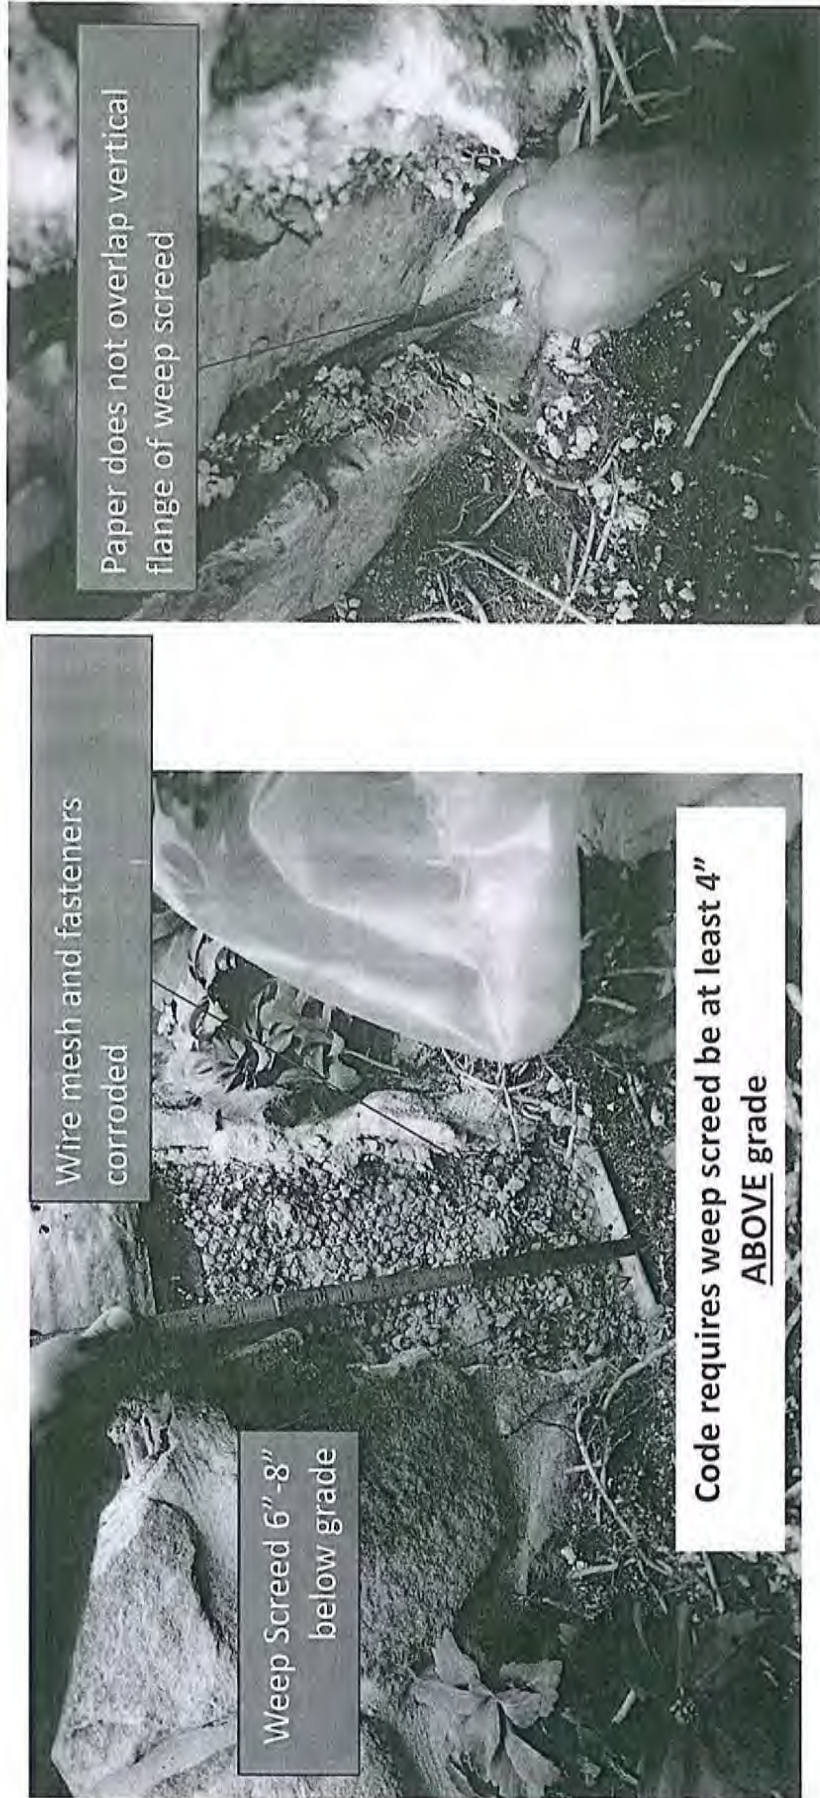
## Invasive Inspections: Location #2

**NO SYSTEM DRAINAGE**

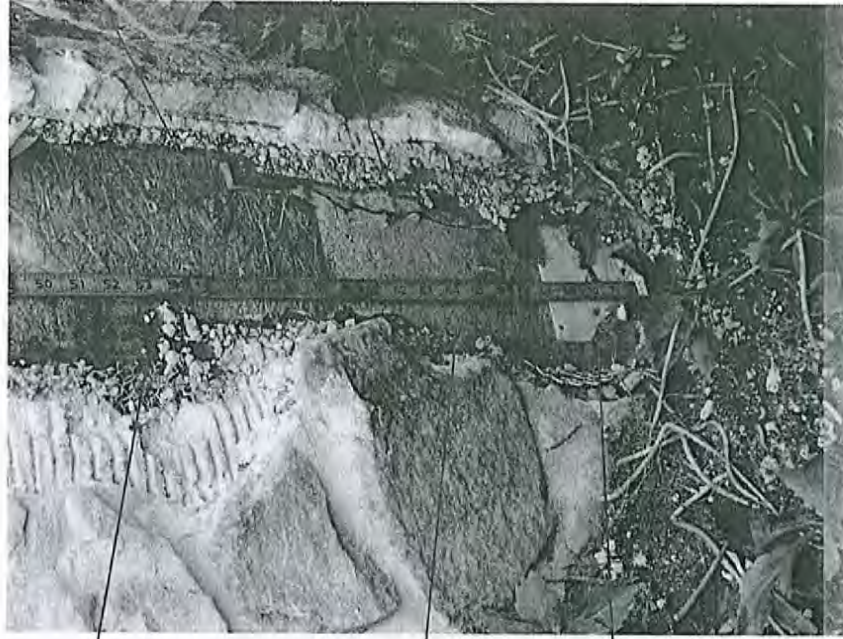
## Invasive Inspections: Location #2

Note: 3 layers of  
building paper +  
drainage mat

Wood Moisture content  
measured at 20% (i.e.: 'wet')

Wire mesh and fasteners  
corroded

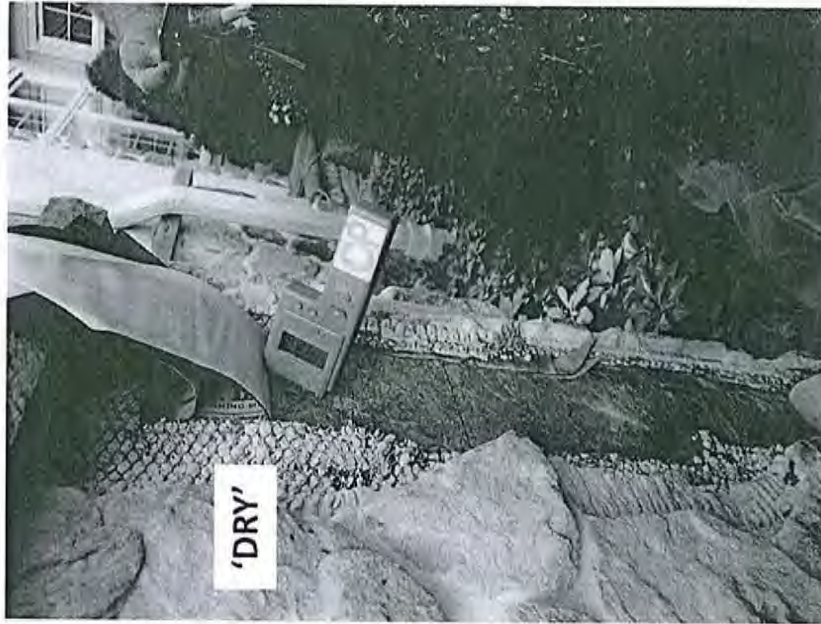
## Invasive Inspections: Location #2

12.6% moisture approx. 32"  
above grade

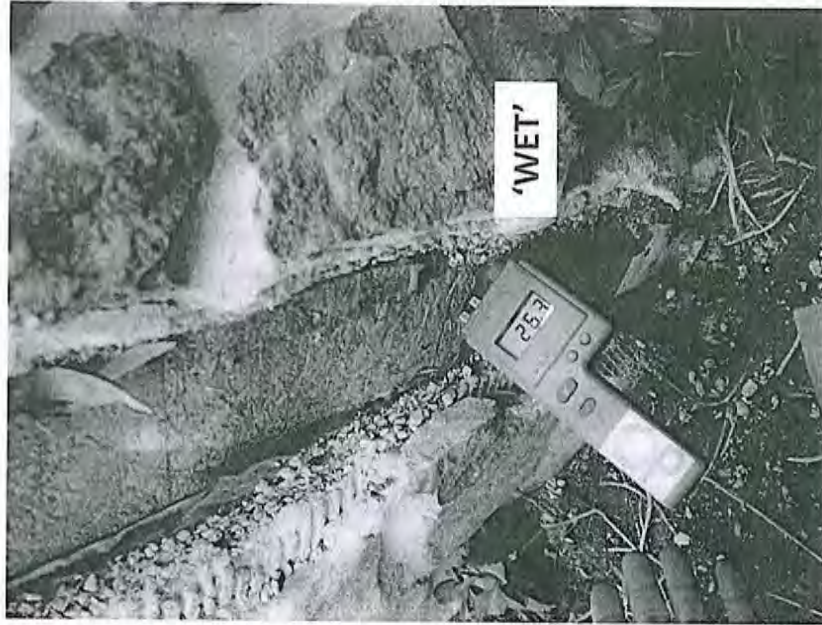
26.3% moisture at bottom of  
wood framing

Buried weep screed  
is preventing  
moisture from  
draining at the  
base of the wall

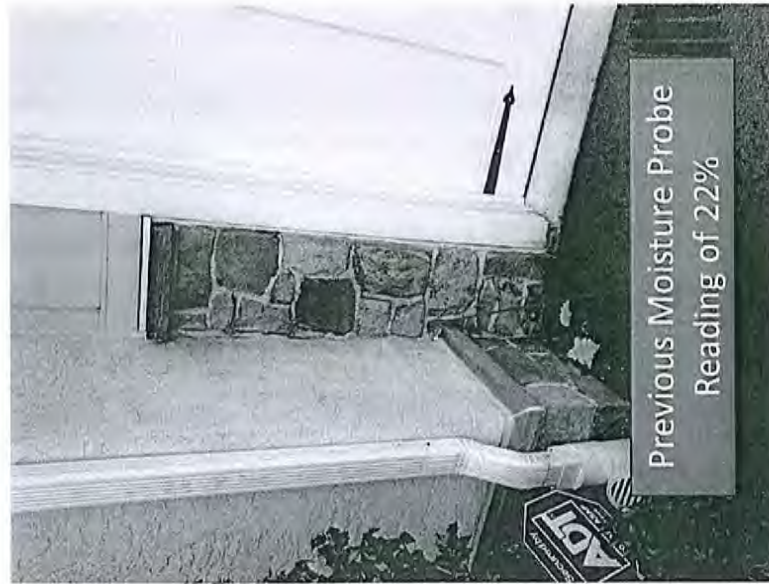
## Invasive Inspections: Location #3

Wire mesh and fasteners  
corroded

Casing Bead Installed Above  
Stone Sill

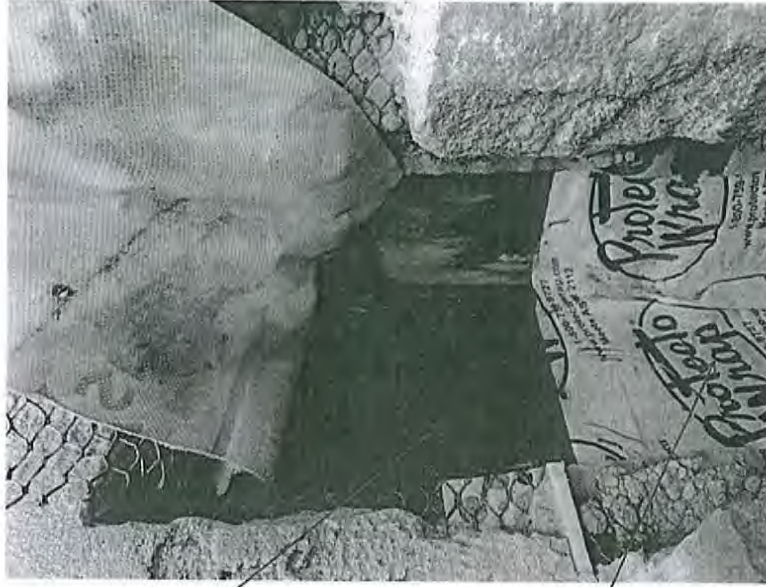
Behind Stone  
-Drainage Mat  
-Building Paper  
-Housewrap

Self-Adhered Flashing  
Between Sheathing &  
Foundation

# HIGH MOISTURE LEVELS

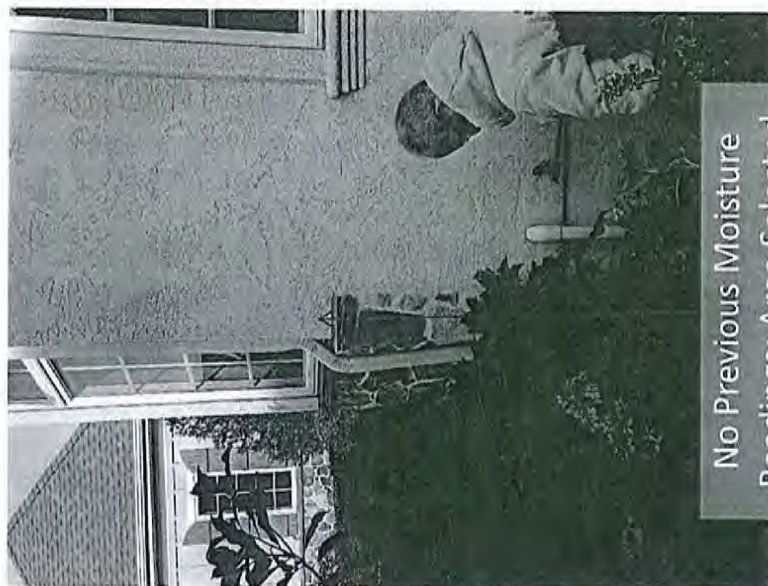
## Invasive Inspections: Location #4

No Previous Moisture Readings; Area Selected to Determine if Drainage Mat is Installed Behind Stucco

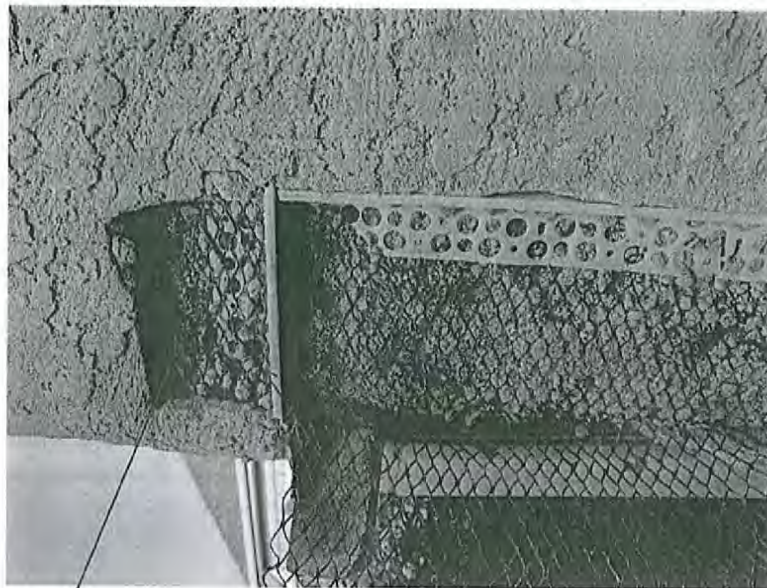
Drainage Mat Verified Behind Stucco

Casing Bead Installed Above Stone Sill

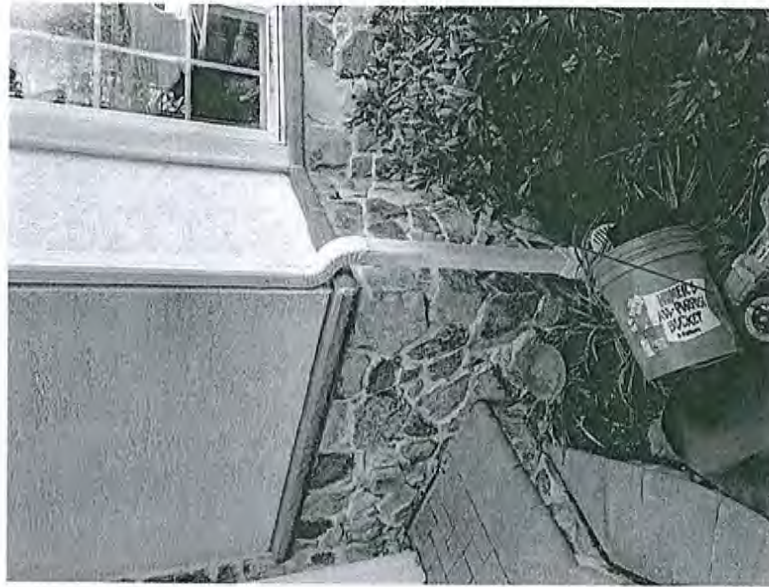
## Invasive Inspections: Location #6

Previous Moisture Probe  
Readings of 30%-40%  
(questioned by Spotlight)

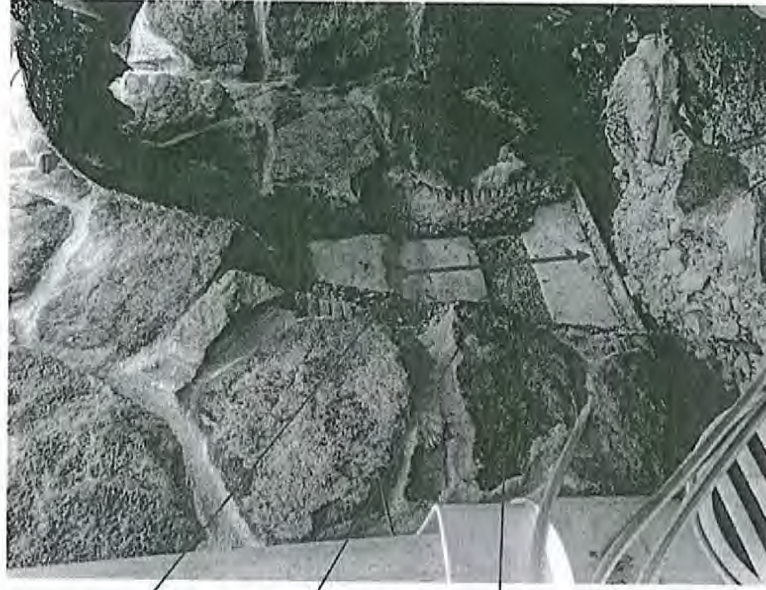
Corrosion of Mesh &  
Fasteners

Housewrap Does Not Extend  
To Weep Screed  
(approx. 6" short)

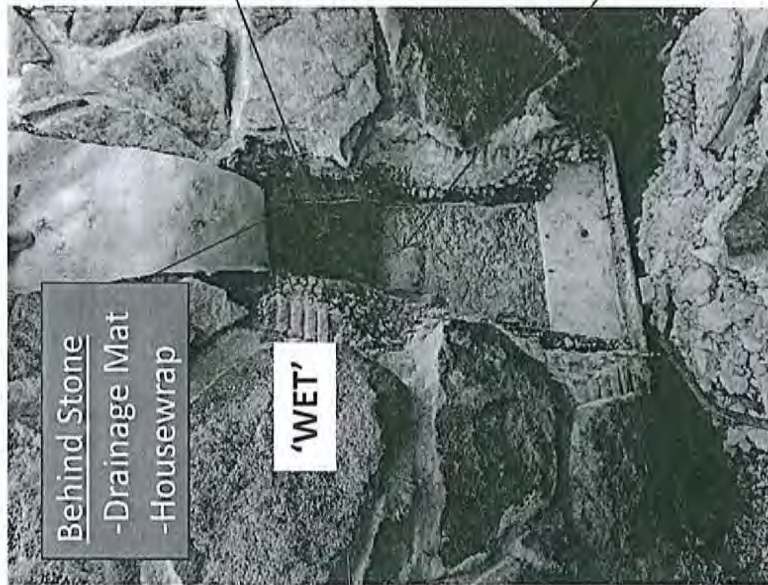
## Invasive Inspections: Location #6

HIGH MOISTURE LEVELS

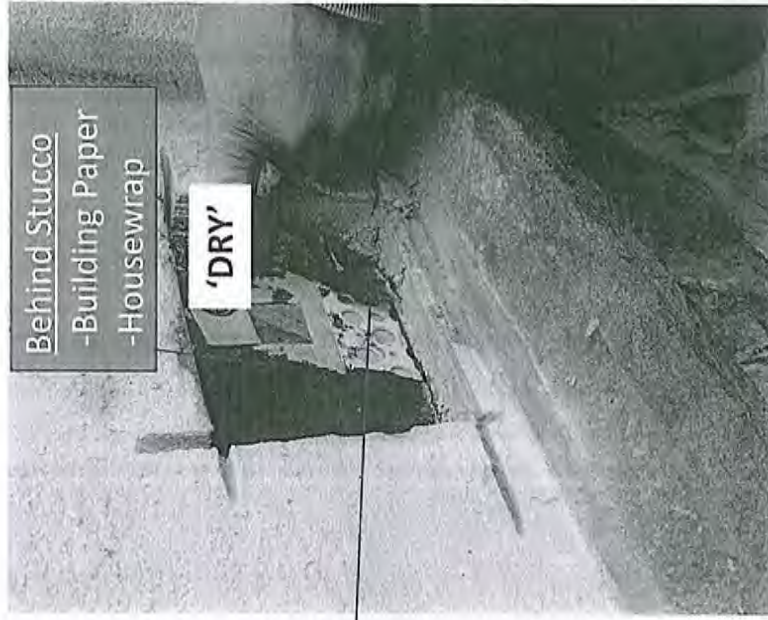
NO DRAINAGE

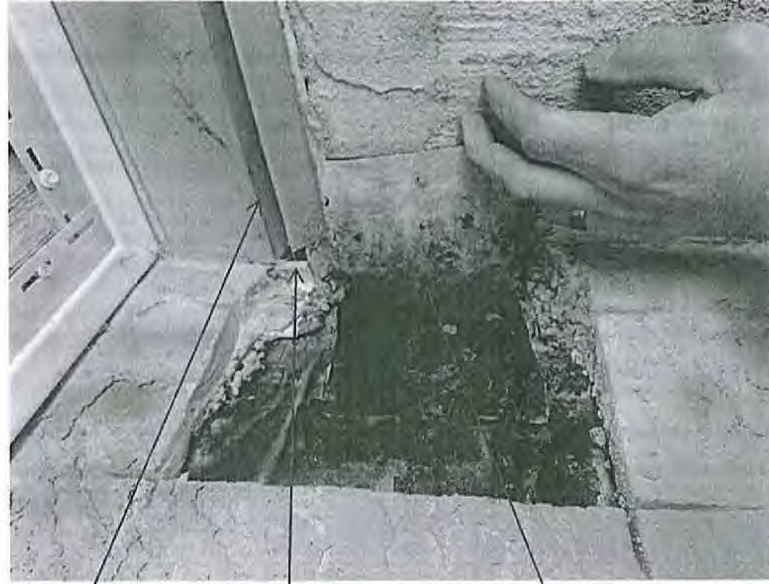
Previous Moisture Probe  
Readings of 34%

Horizontal Trim Installed Tight  
to Flashing

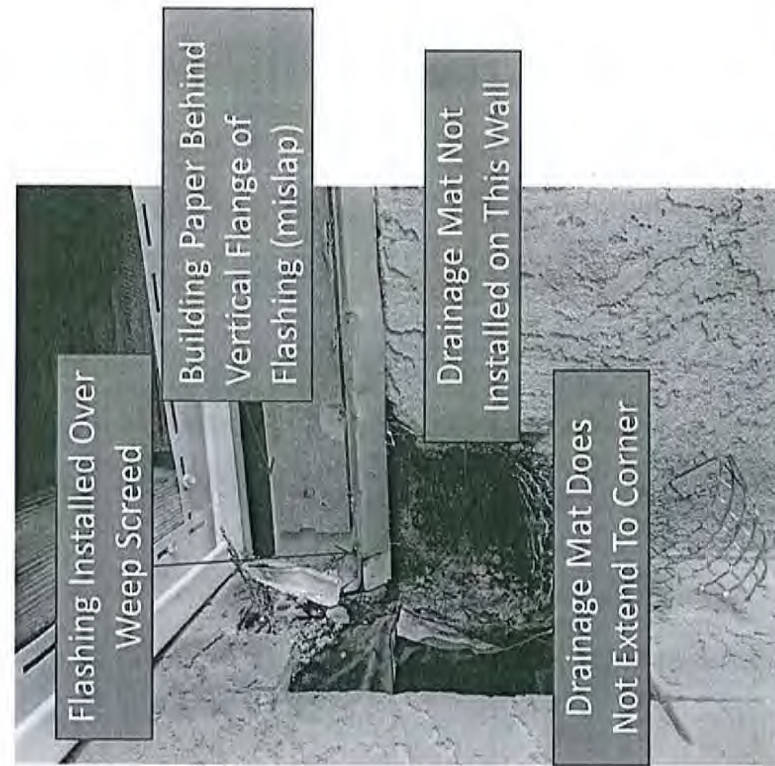
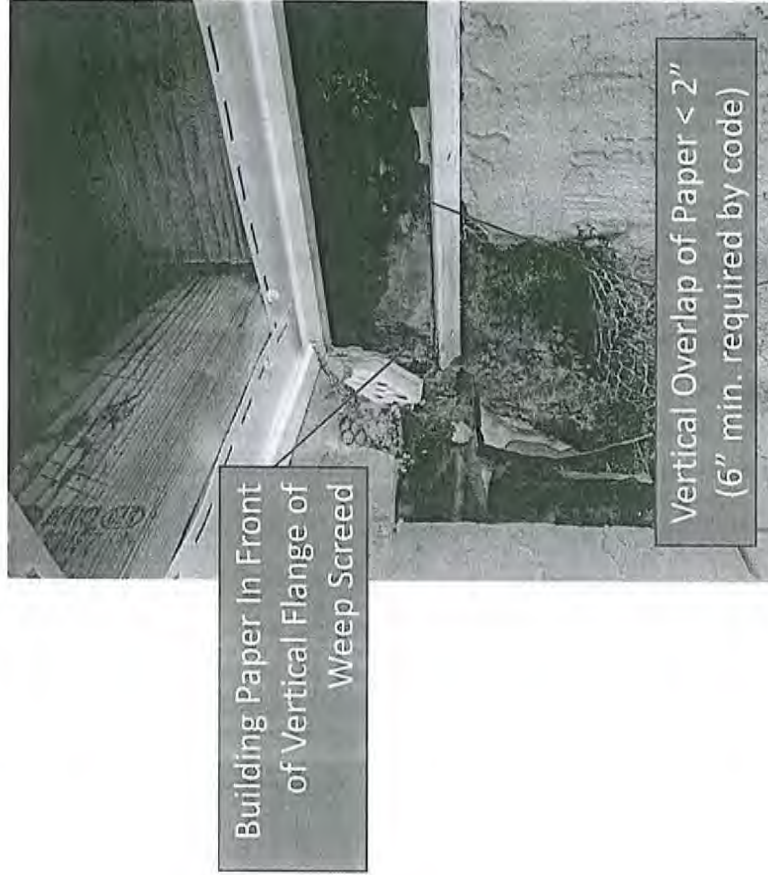
## Invasive Inspections: Location #7

# NO DRAINAGE

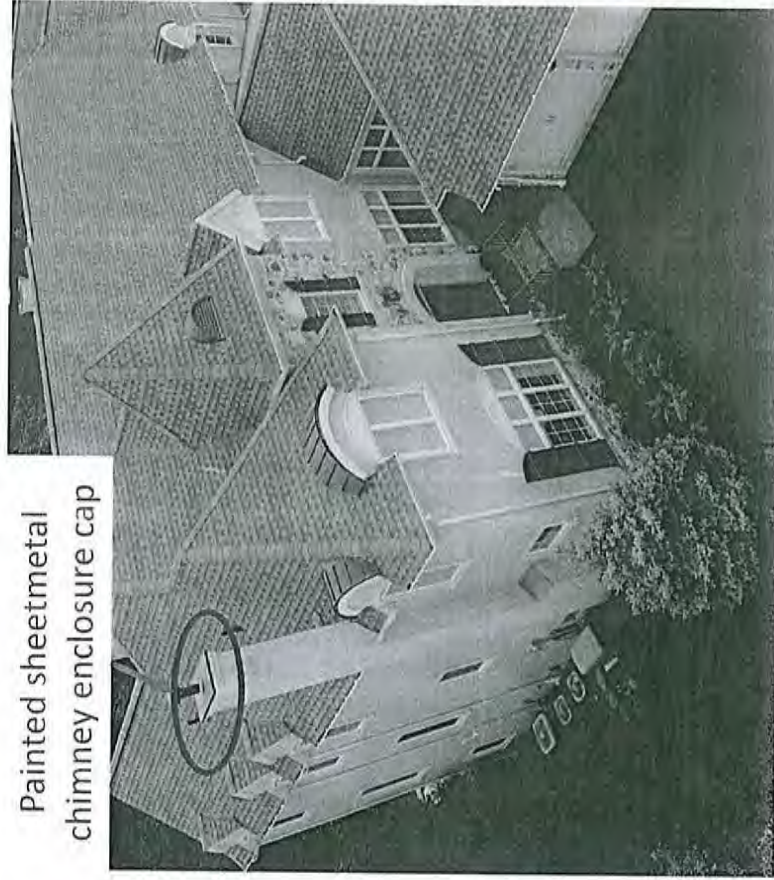
Painted sheetmetal  
chimney enclosure cap

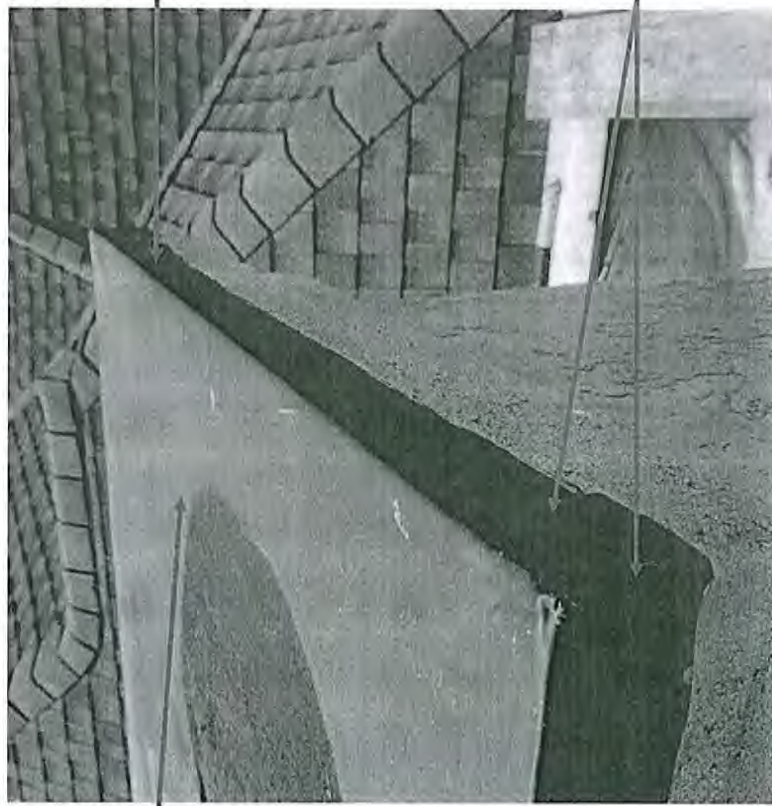
# 212 Valley Ridge Road Chimney

NOTE: This alone is not a direct violation of code, but the lack of slope allows water to pond on the surface of the cap. This ponding water will accelerate corrosion

ISSUE: Projecting flanges/drip edges not provided on pan skirt. This does not meet industry standard requirements for installation of the sheet metal as outlined in the manual prepared by SMACNA.

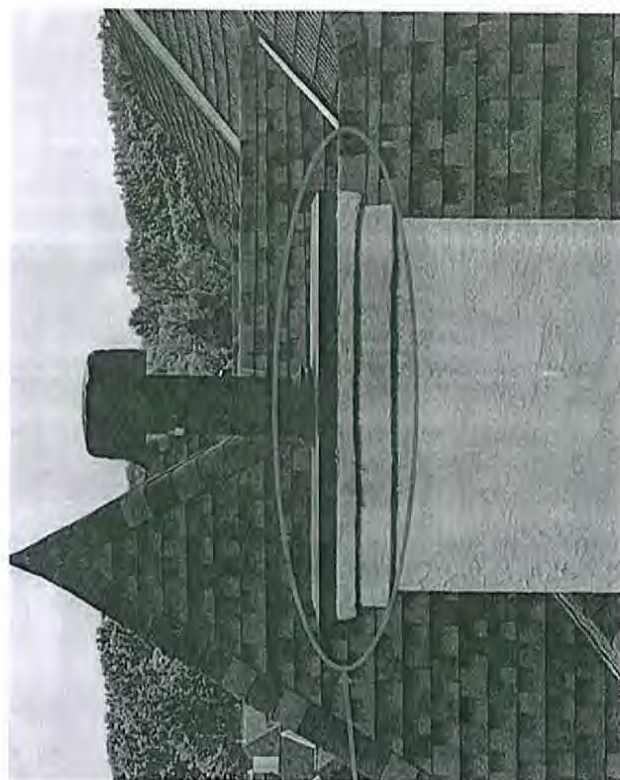
## Improper Execution of Architectural Feature

Architectural shadow board  
feature

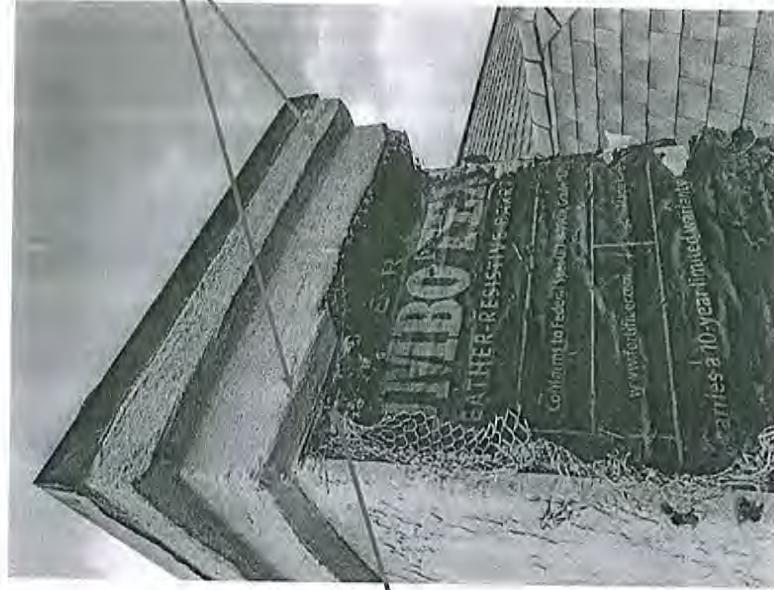
## Improper Execution of Architectural Feature

ISSUE: Drainage opening not provided between horizontal and vertical plaster surfaces. Does not meet requirements of ASTM C929 (required by the building code/IRC)

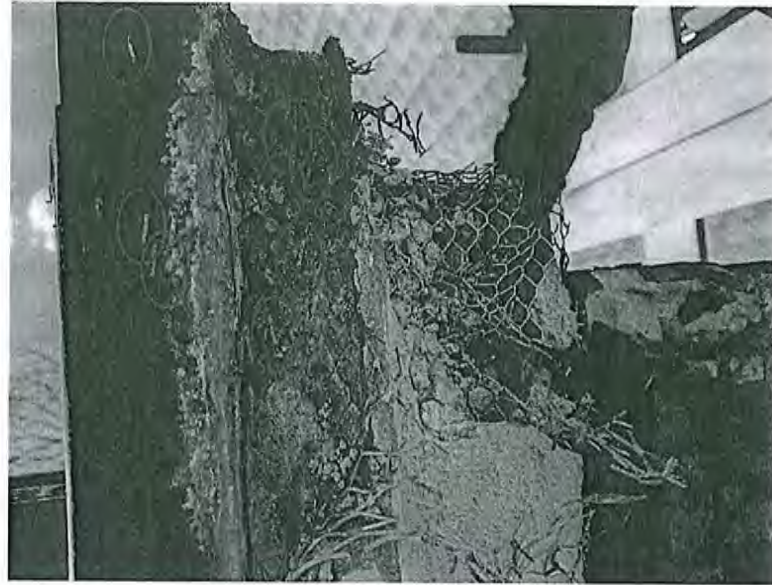
### Improperly Installed Weather-Resistive Barrier

ISSUE: Excessive number of penetrations through WRB layers create leaks

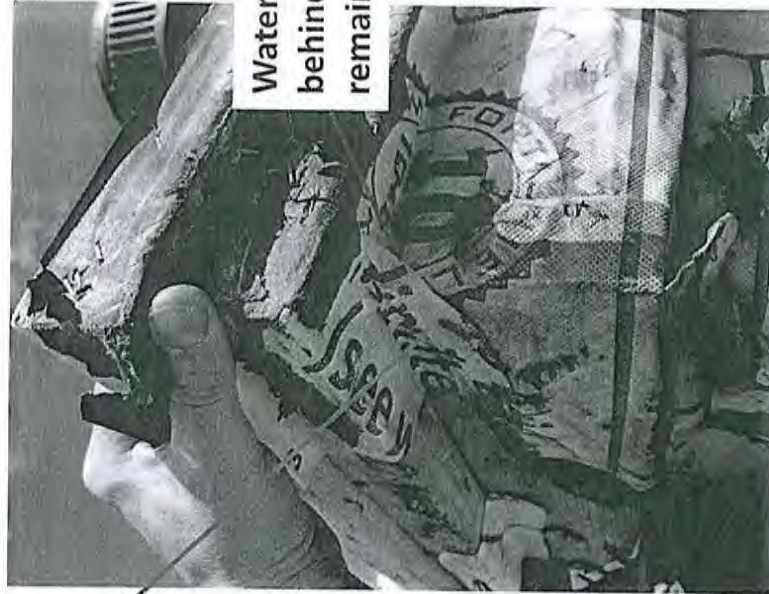
Does not meet building code requirements

Water infiltrates behind WRB and remains trapped

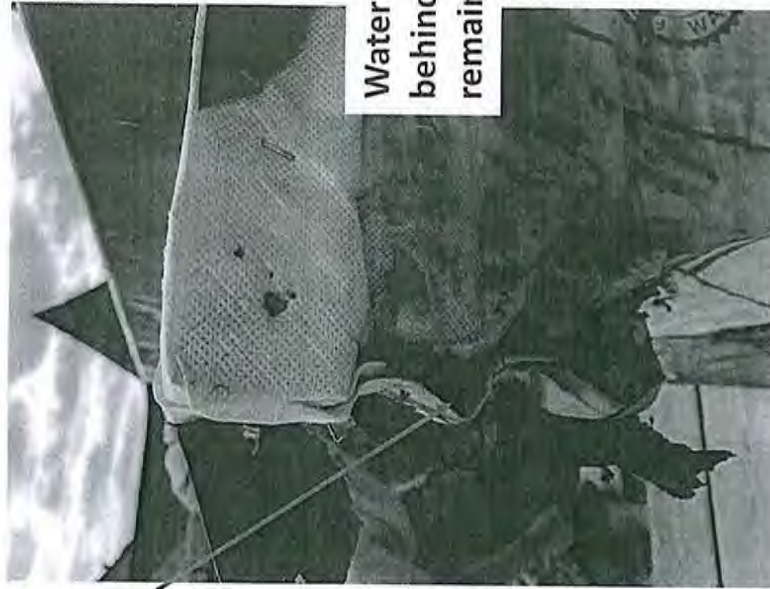
Water infiltrates behind WRB and remains trapped

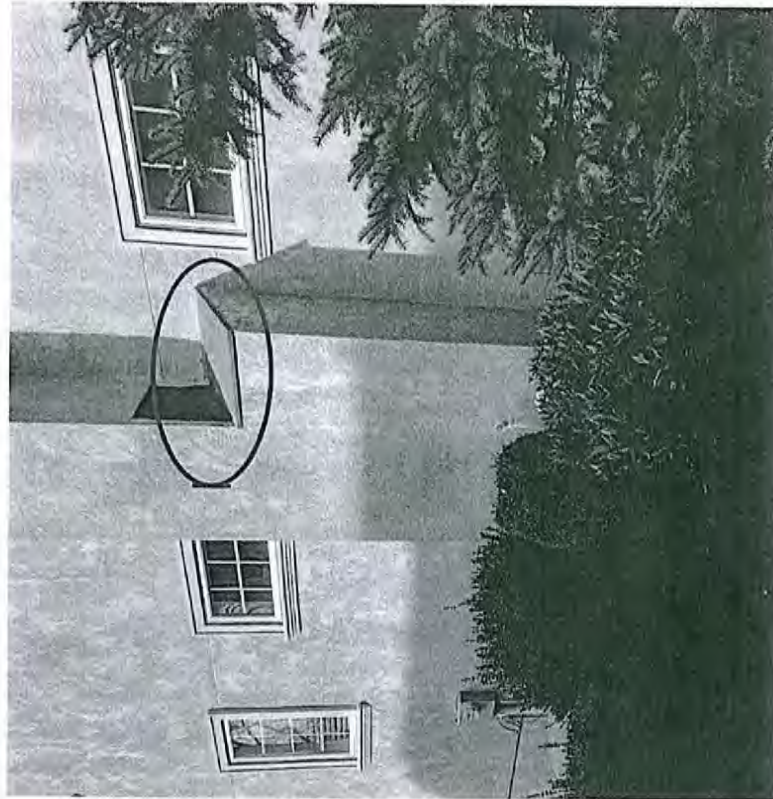
### Improper Underlayment at Chimney 'Shoulder'

ISSUE: Improper material type for waterproofing a horizontal surface. Insufficient overlap/discontinuous WRB

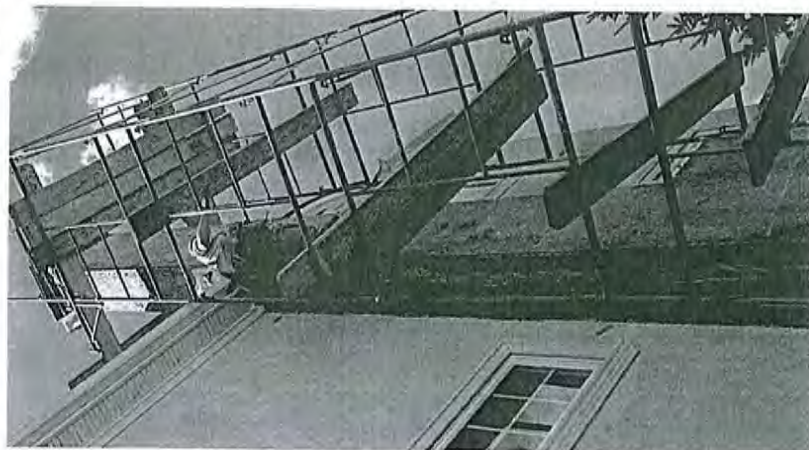
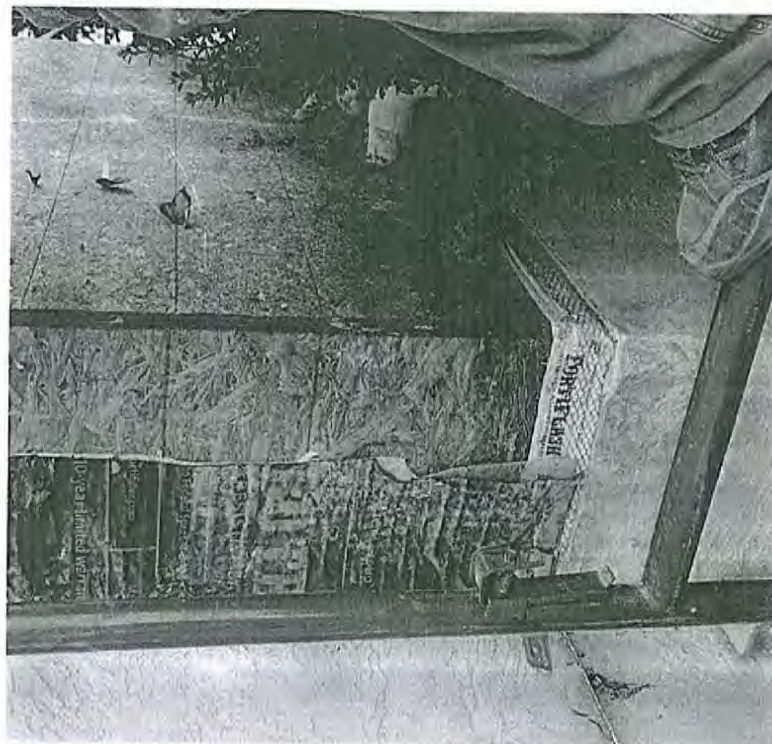
Moisture Damage and Wet Sheathing as a Result of the Defective Construction

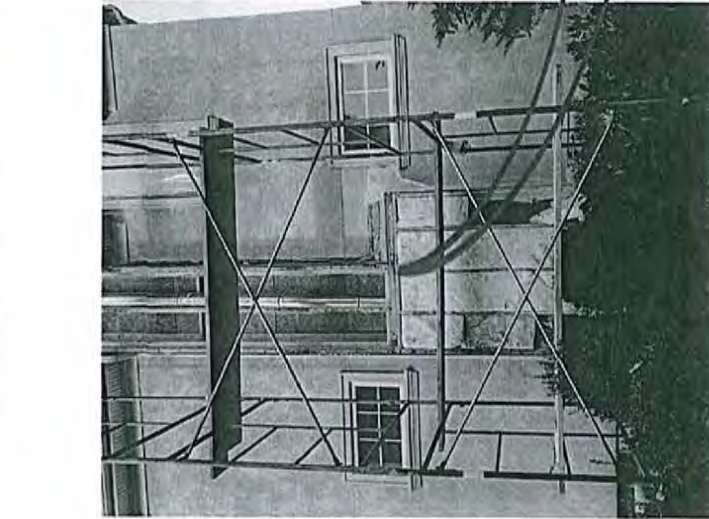
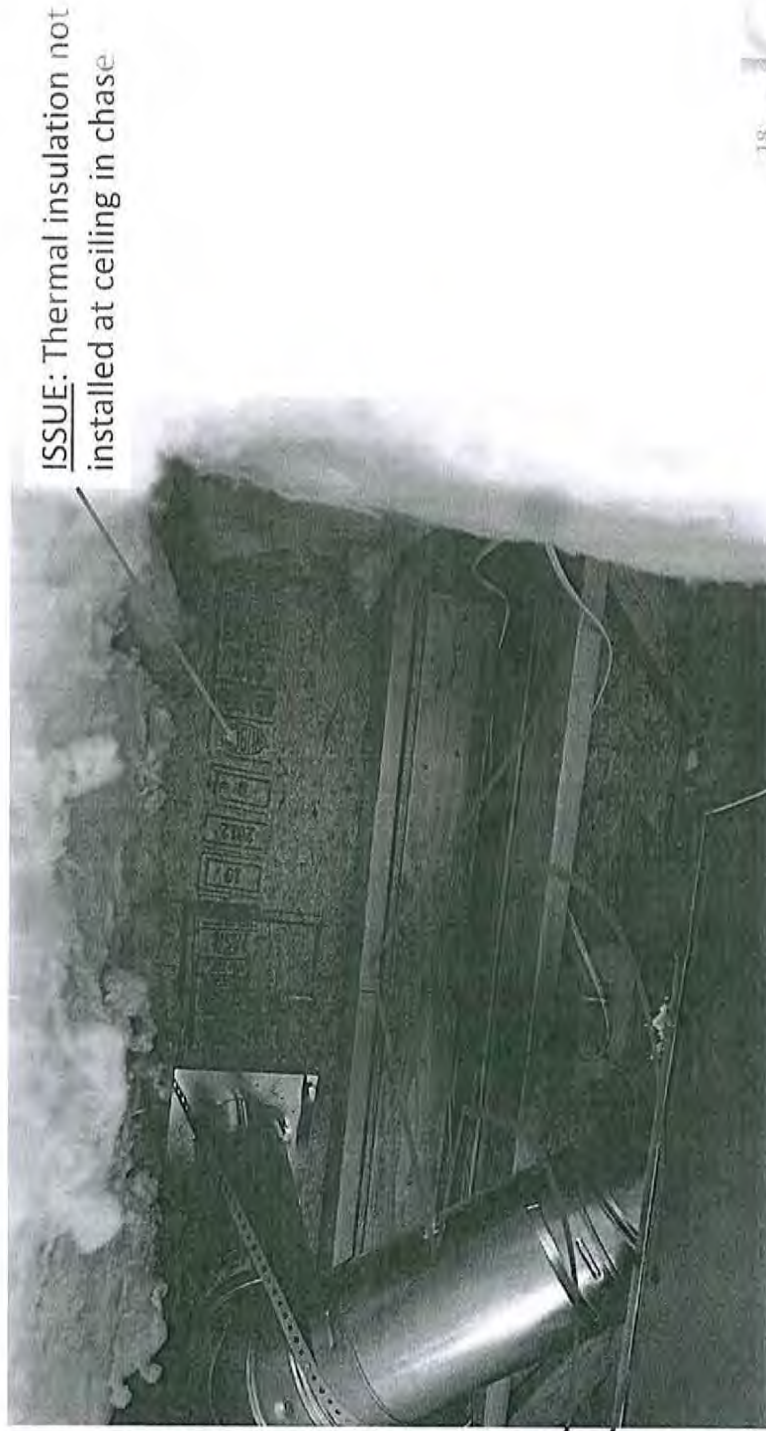
Discontinuous Thermal Envelope Leads to Heating and Cooling Inefficiencies in the Home and is a Building Code Defect.
